**GEOTECHNICAL SUBDIVISION COMPLETION REPORT
(INSPECTING ENGINEERS REPORT)
FRONTIER DEVELOPMENTS SUBDIVISION – Stage 3
PIONEER DRIVE, TE AWAMUTU**

**Re: Geotechnical Completion Report - Soils and Earth Fill Report,
Frontier Developments Residential Subdivision
Stage 3 - Lots 42 to 64
Pioneer Drive, Te Awamutu**

**GEOTECHNICAL SUBDIVISION COMPLETION REPORT
(INSPECTING ENGINEERS REPORT)
FRONTIER DEVELOPMENTS SUBDIVISION – STAGE 3
PIONEER DRIVE, TE AWAMUTU**

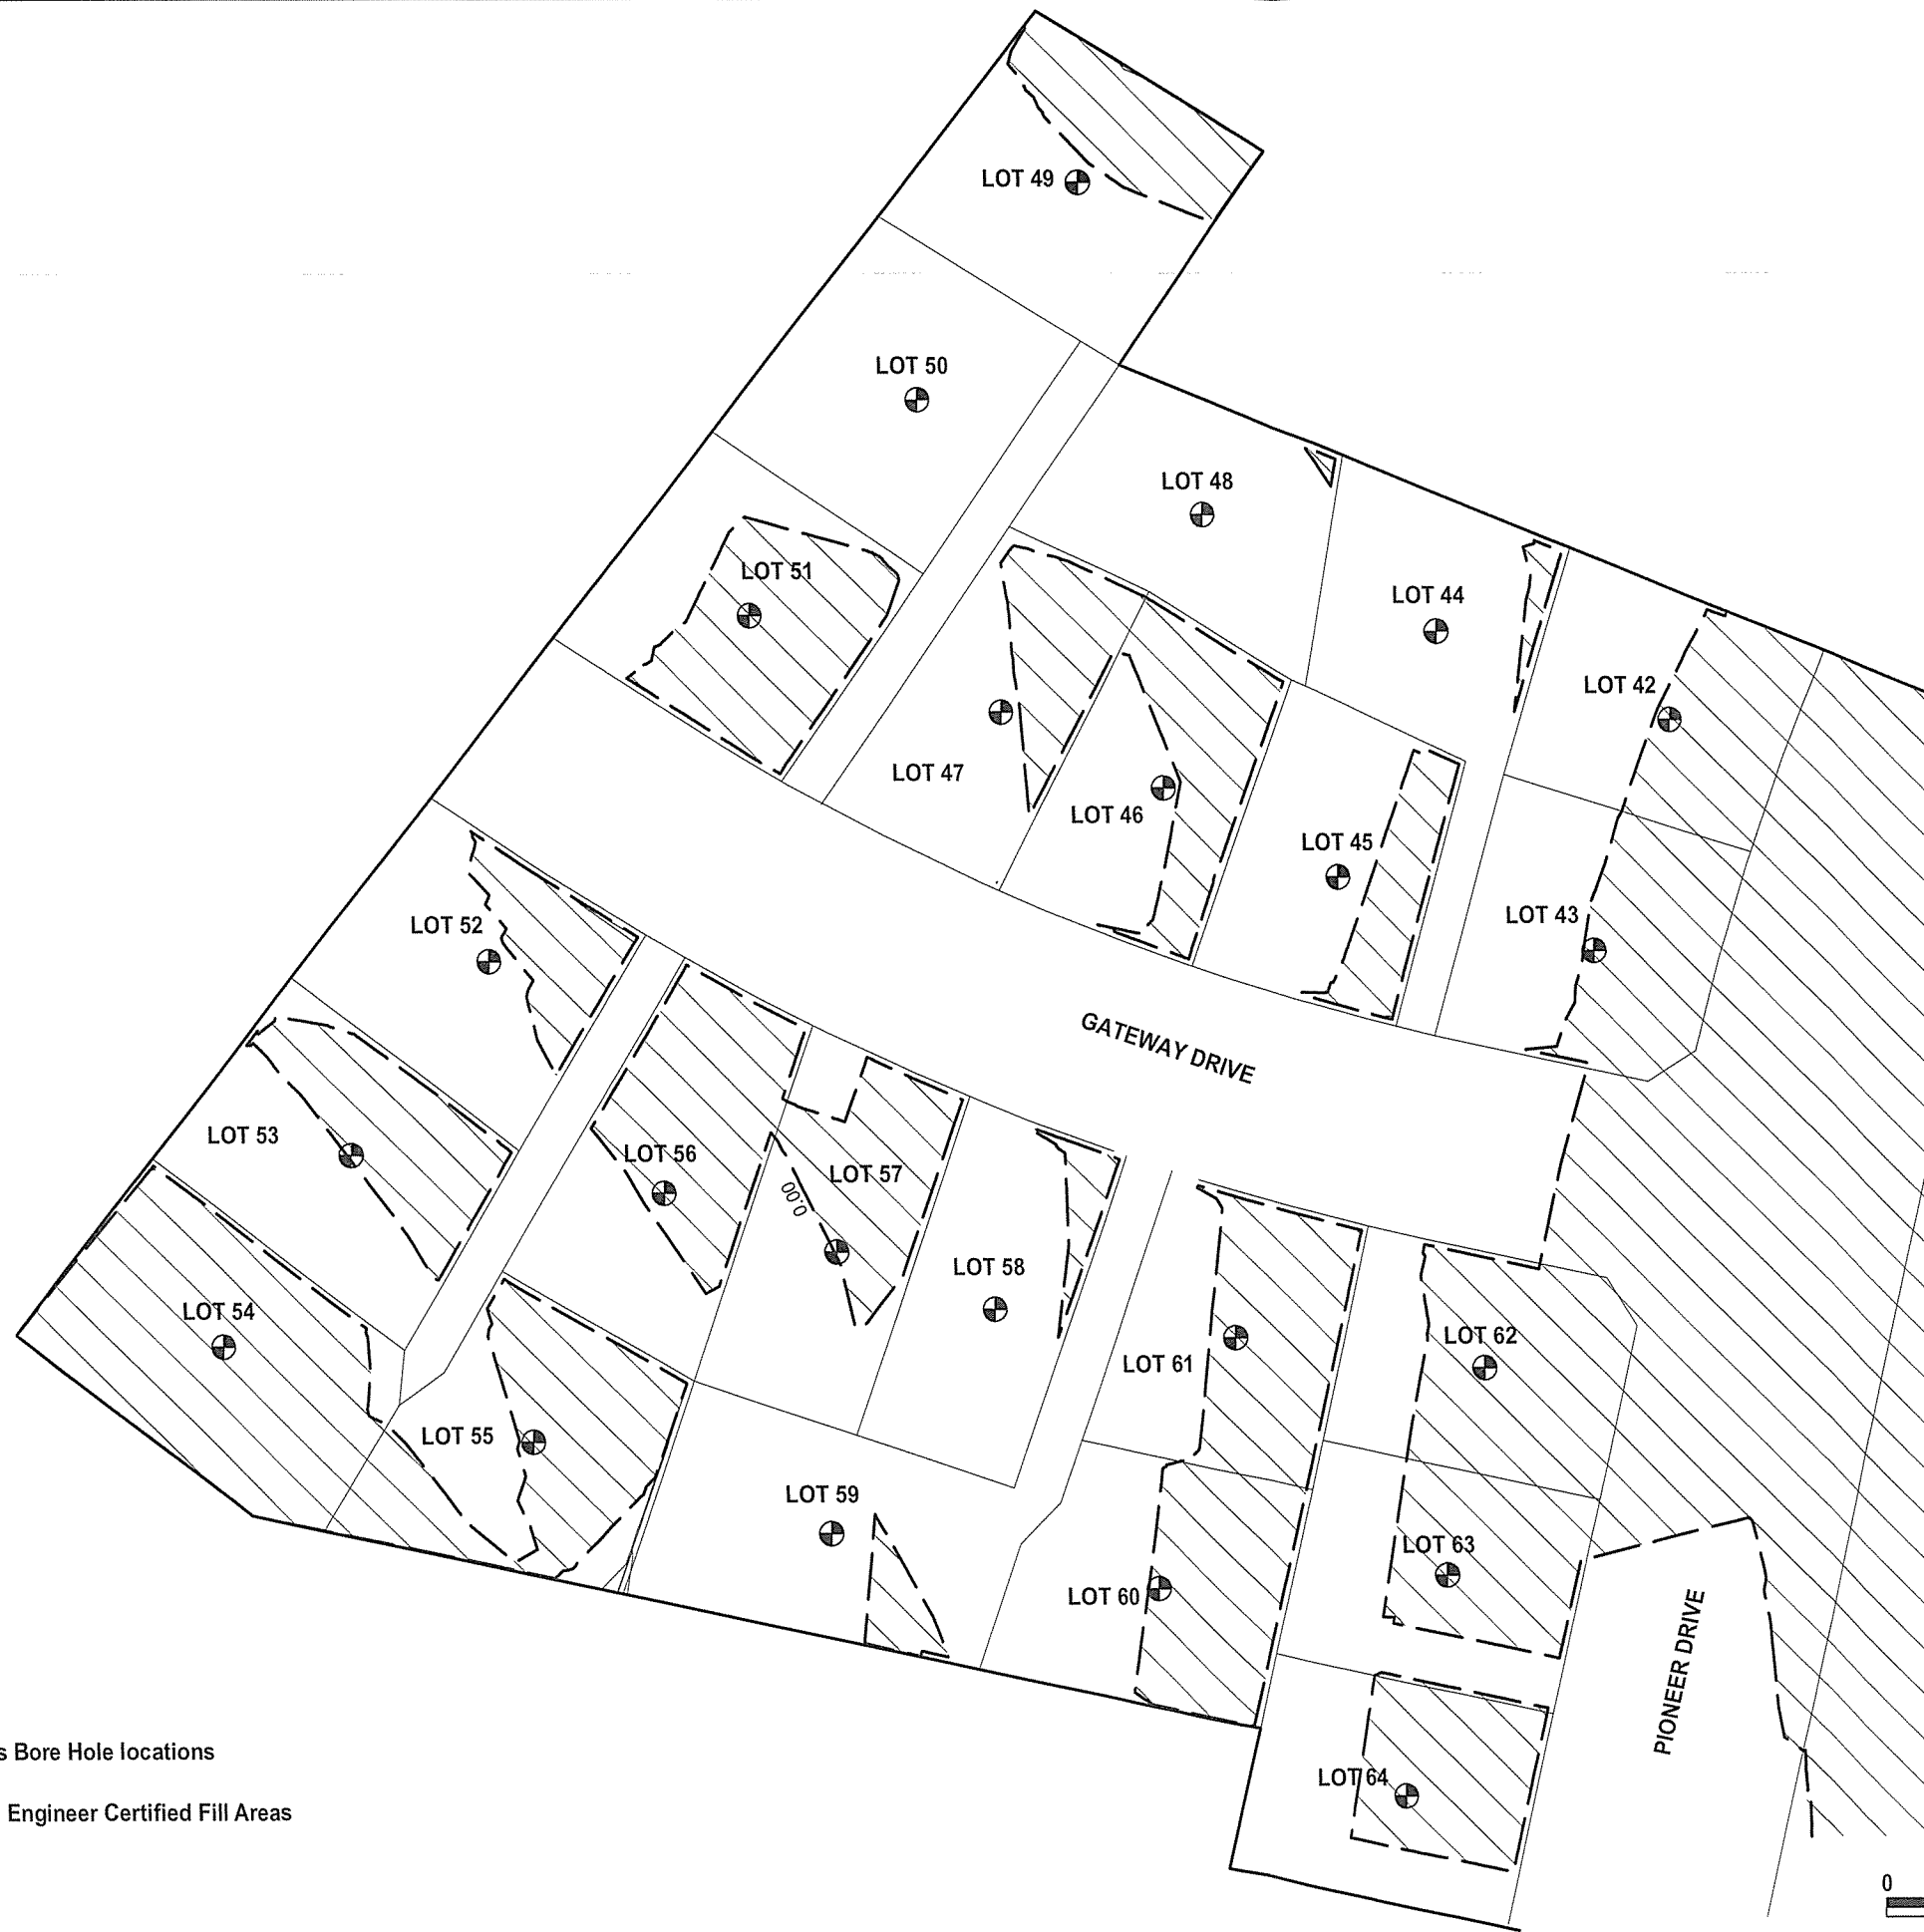
DRAWING No. 16638-10

The soil conditions within the Stage 3 project site were investigated by drilling, twenty three, 2.0 metre hand auger test borings, together with Scala Penetrometer probe and in-situ shear vane tests at the centre point of each lot, as shown on the attached Site Plan. The designated bore hole number corresponds to the relevant Lot number, with Bore Hole Logs and associated test results presented on Figs. A-1 to A-12.

denotes Bore Hole locations
-

" Engineer Certified Fill Areas
