Geotechnical Report

Stage 01 & Stage 02 - Frontier Estate Subdivision,
Pioneer Drive & Saddle Terrace, Te Awamutu.
Lots 2 to 41

**GEOTECHNICAL SUBDIVISION COMPLETION REPORT
(INSPECTING ENGINEERS REPORT)
FRONTIER DEVELOPMENTS SUBDIVISION – Stage 1
Lots 2 to 41
PIRONGIA ROAD, HAMILTON**

4 December, 2019

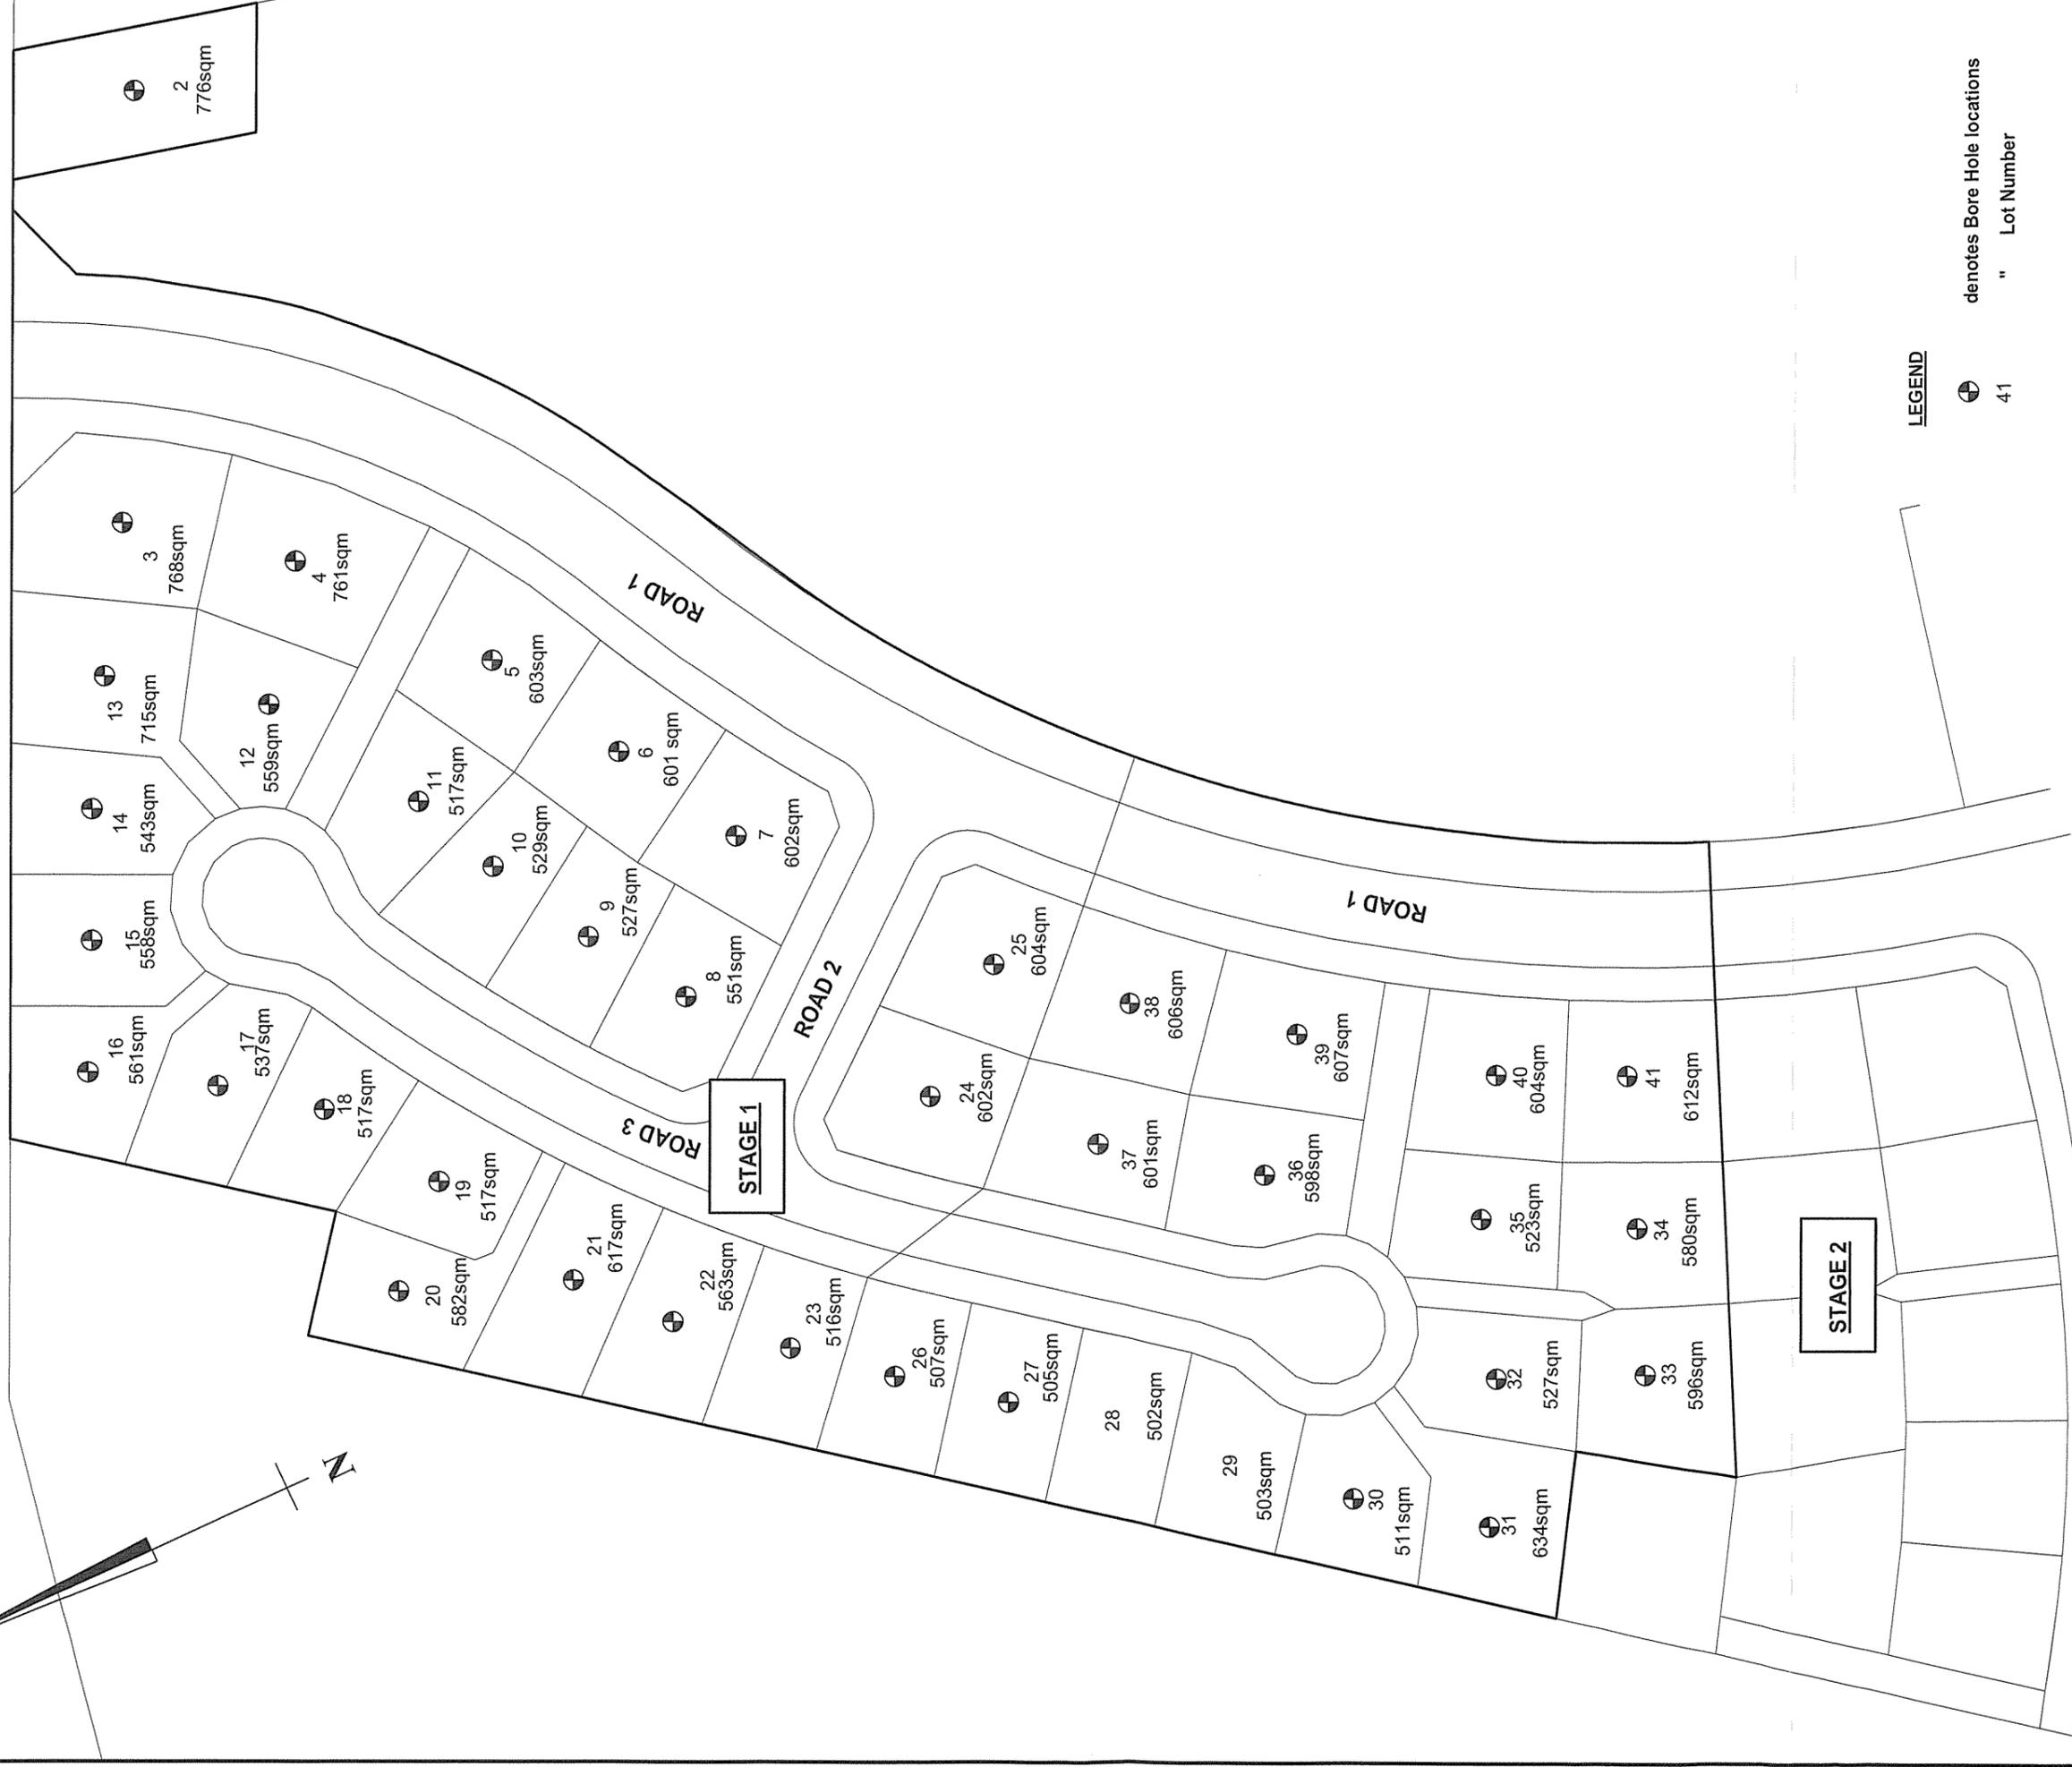
PIRONGIA ROAD

The soil conditions within the Stage 1 project site were investigated by drilling forty hand auger test borings, together with Scala Penetrometer probe and *in-situ* shear vane tests at the centre point of each lot, as shown on the attached Site Plan. The designated bore hole number corresponds to the relevant Lot number, with Bore Hole Logs and associated test results presented on Figs. A-1 to A-20.
